Technical Case Study

Re-designing a library lighting system

Enlighten Solutions

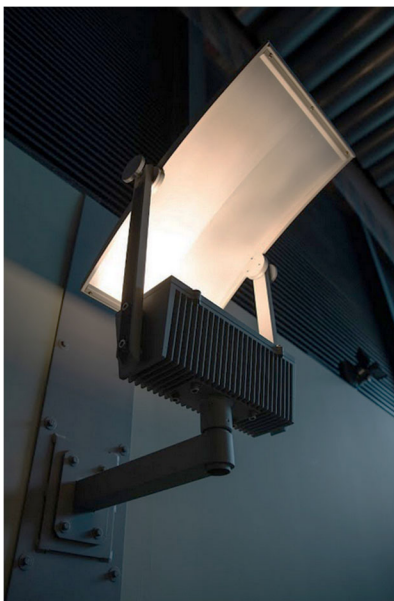
Left: Indirect Post Top Fixtures intended to spill some light onto ceiling and reflect most light back down to task plane

Upon initial survey, Enlighten found approximately half of the indirect post top lights to be non-functioning and 100% of the spot lights to be non-operable. Yes. That is correct. 100% of the spotlights were out. Both of these sets of luminaires were difficult to access requiring a specialized lift and the removal of a significant number of the 2nd floor's bookshelves. Thus, the reason maintenance had not been able to be performed.

The inevitable solution was a whole new fixture and approach was needed to replace the old indirect post tops. This new luminaire would provide 100% downlight thus making 30 foot candles much more achievable. Moreover, a forward throw pattern was utilized in order to keep too much light from being directed back onto the truss wall, raising potential glare issues, and not targeting light towards the task plane efficiently. To complement the red brick tones, 3000K was utilized.

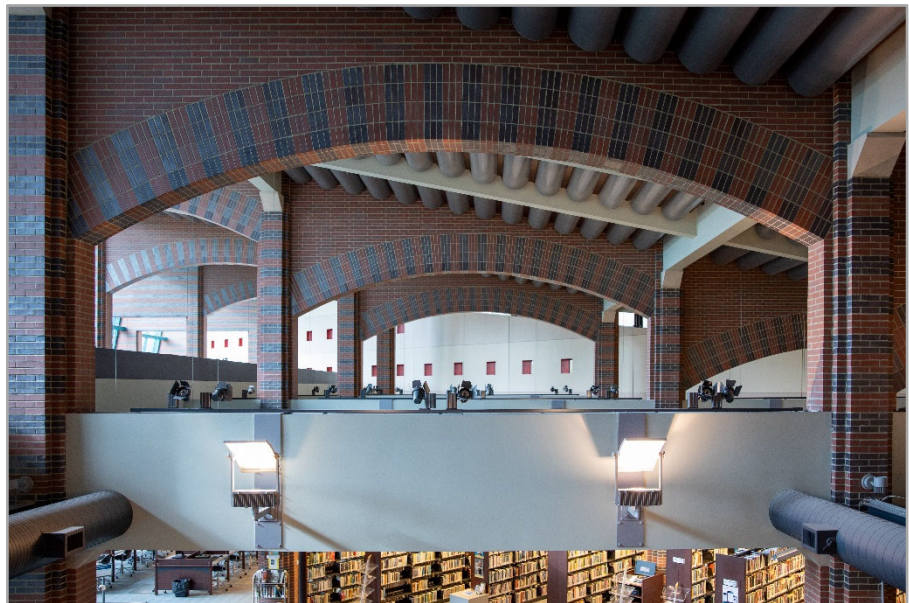
Right: Spot Luminaires intended to provide archway and ceiling uplight. Overall system state and lighting poor before conversion

To help resolve some of these issues, Enlighten would recommend long life post-top fixtures (L70 > 150,000) with integrated surge protection and glass lenses to prevent yellowing. For the spotlights, we would recommend commercial grade PAR30 LED lamps. These lamps provided much longer warranty periods, higher L70 hours, and increased lumen output compared to standard LED PAR30's.

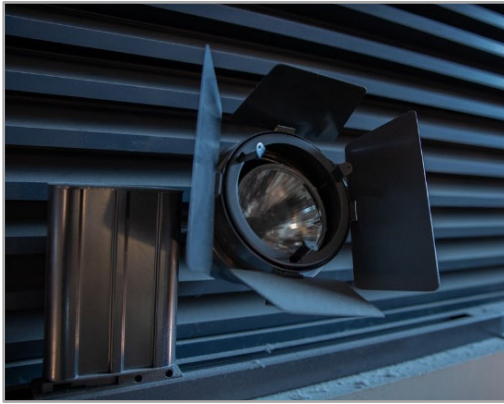
100% of the 118 spot lights were not functioning!

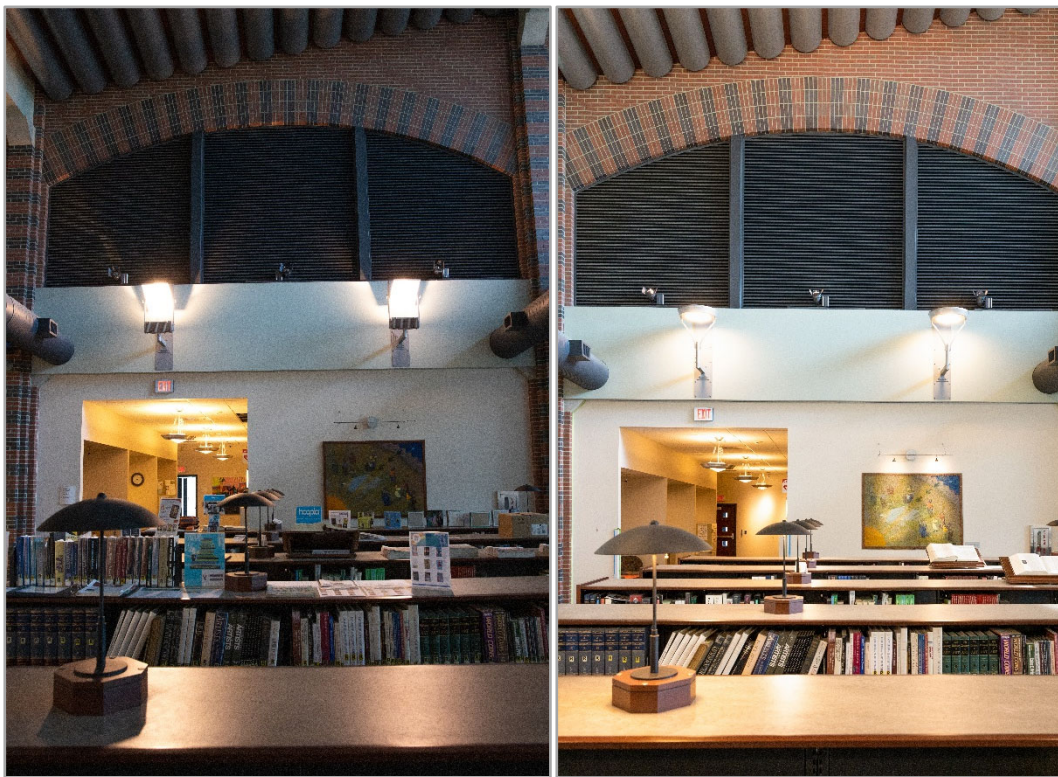
Left / Before: Poor task plane illumination, high glare from operating post tops, no uplight from broken spot luminaires
Right / After: 30 foot candles on task plane, balance fixture glare compared to surrounding luminances, balanced uplight
