Technical Case Study

Re-designing a library lighting system

Enlighten Solutions

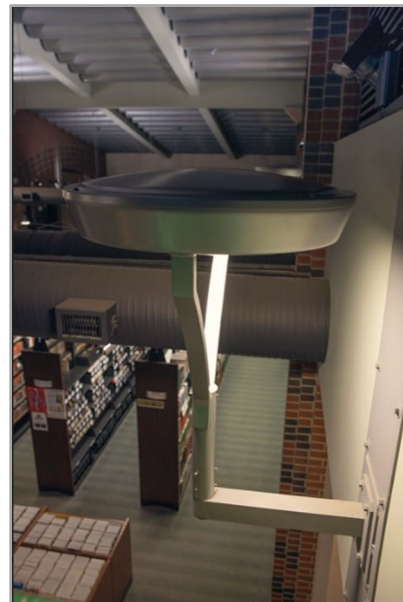
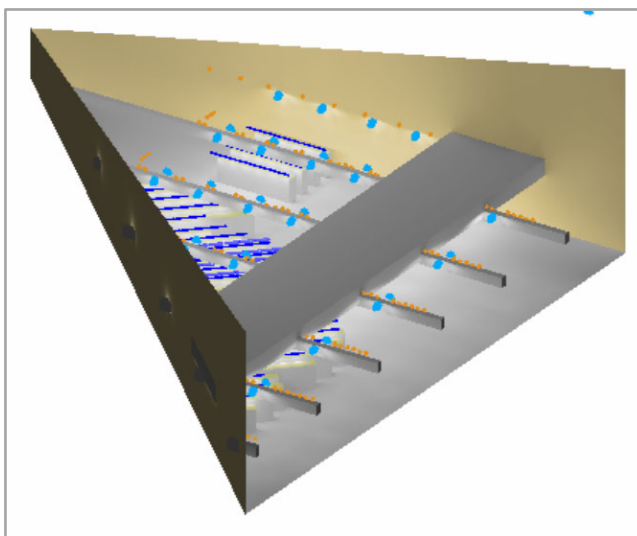
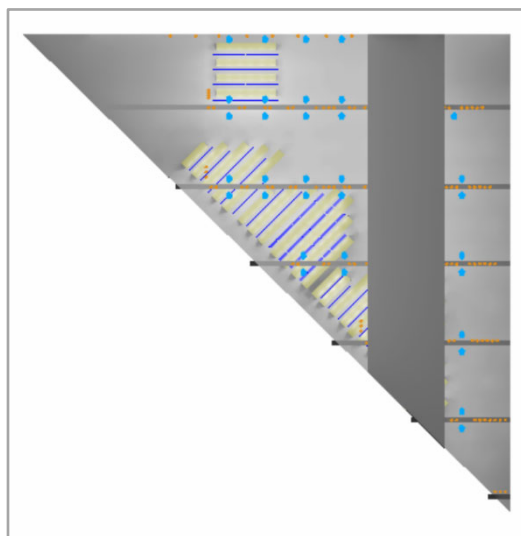
Left: 3D Photometric Analysis Perspective | Right: 3D Photometric Analysis Aerial

In order to confirm this new lighting would achieve the intended illumination goals, Enlighten provided 3D photometric analysis projecting task plane illuminances and vertical surface luminance ratios.
